JimWalter Resources # 5 Coal Mine Disaster

September 23, 2001;

A United Mine Workers of America Report

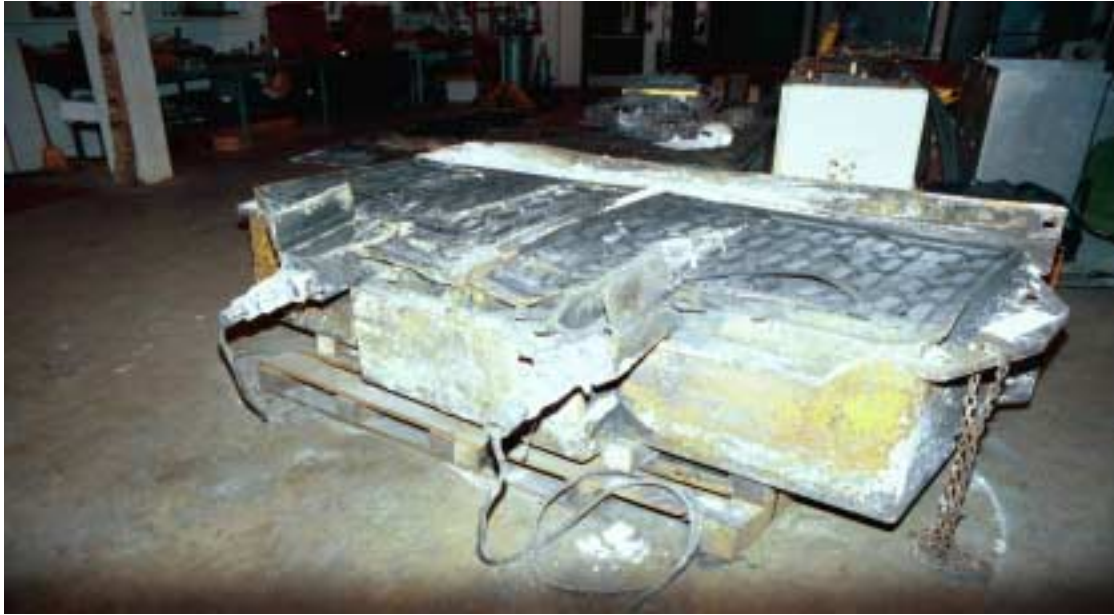
It is believed that the scoop battery, which was hung from the roof that fell, was the likely ignition source of the first explosion. It is considered the likely ignition source due to its proximity to methane that likely migrated from the roof fall. The restricted ventilation in the area, damage to the battery terminals and leads caused a short-circuited capable of generating sufficient heat to ignite methane.

Pictured below is the Douglas Battery recovered from the roof fall on No. 4 section. It is believed to be the ignition source of the first explosion.
